THIS OLD TRUCK

Pro Paint Tips: Prepping and Reading Body Surfaces

We continue our coverage of the restoration of “This Old Truck” as it was treated to professional paint preparation at Brea Hills Auto Collision in Brea, California. Our last episode ended with the steel cab’s roof being surfaced and the rolled rain gutters shaped with a thin coat of plastic filler. This month we watched as John attacked the cab’s new rear panel, plus he also prepped the doors and cowl with a thin coat of plastic filler and much more sanding than we anticipated.

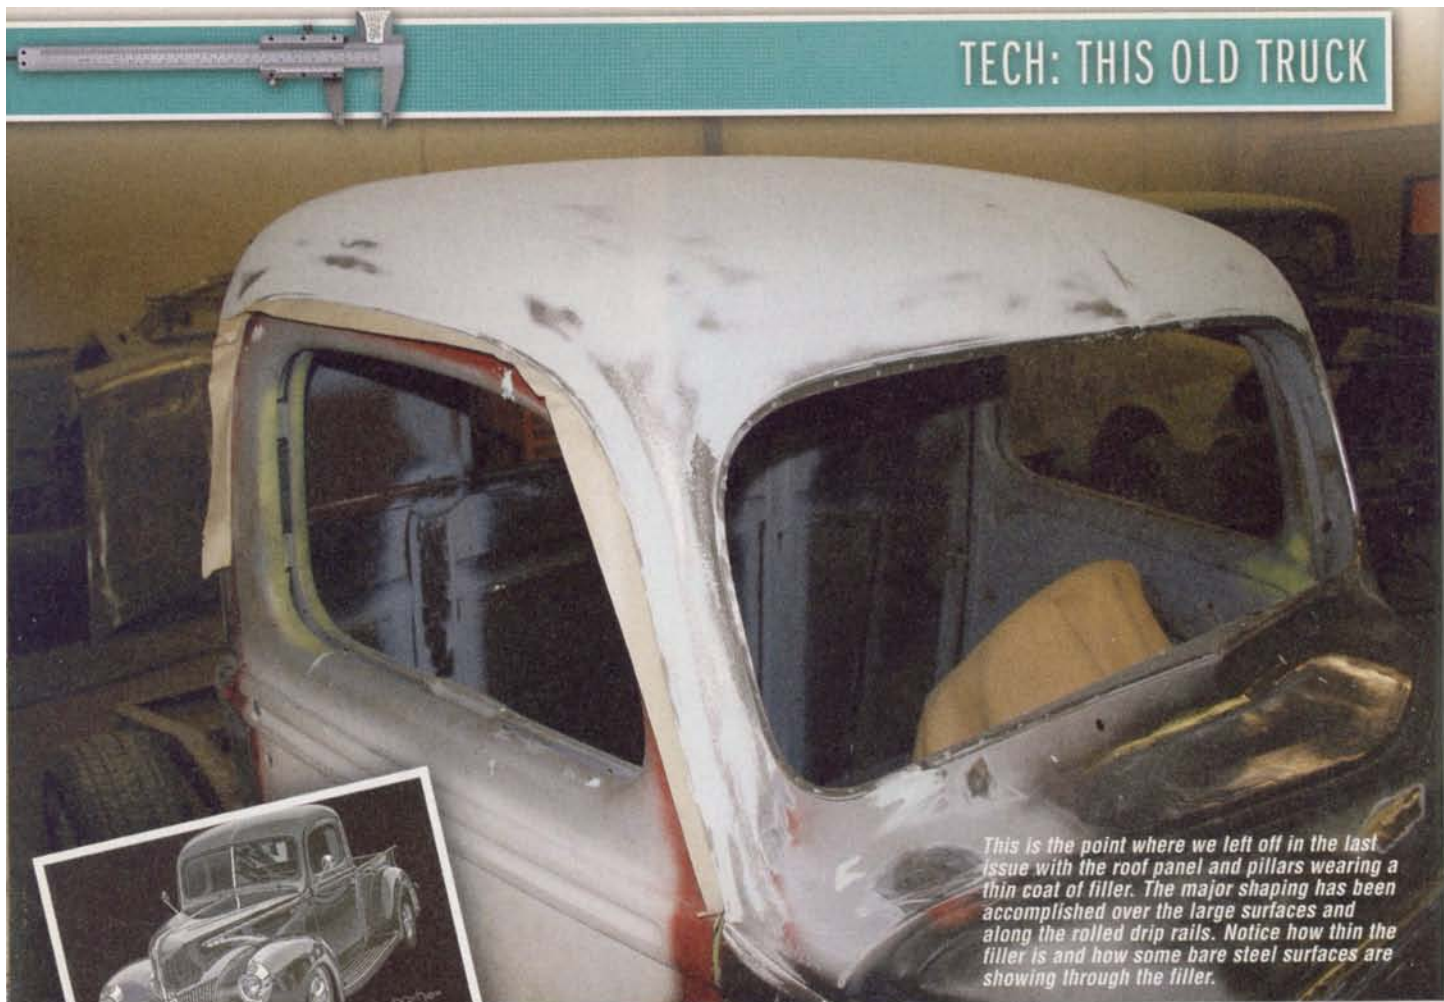
This is the point where we left off in the last issue with the roof panel and pillars wearing a thin coat of filler. The major shaping has been accomplished over the large surfaces and along the rolled drip rails. Notice how thin the filler is and how some bare steel surfaces are showing through the filler.

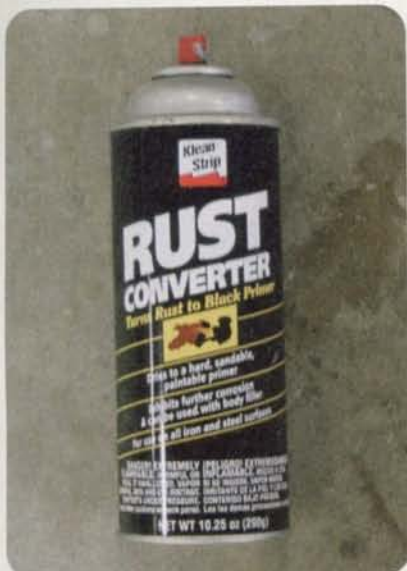
Those areas of the cab's interior where a tool cannot reach into the crevices will be sprayed with Rust Converter, sealing the area to prevent further oxidation.

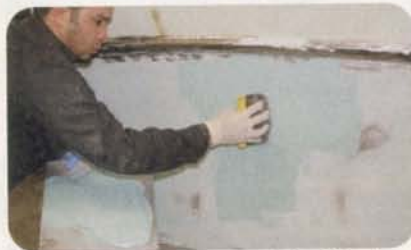
John uses a squeegee to apply the filler in uniformly thin coats on the rear panel. Notice that he is wearing rubber gloves for protection. One goal before catalyzed filler was applied to the rear panel was to keep the large surface from oil-canning (moving in or out). This was important to ensure that the filler material won't crack, and that the eventual topcoat will not be damaged as a result.

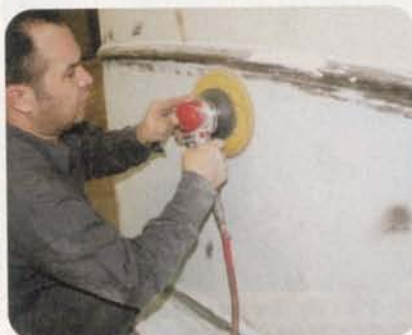
Important Tip: John uses a rotary grinder while the filler is still somewhat plastic to the touch. Other tools that can be used are a "cheese grater" or very coarse sandpaper (40- to 80-grit). Working the surface while it's still curing allows the high areas to be reduced more quickly and with less effort.

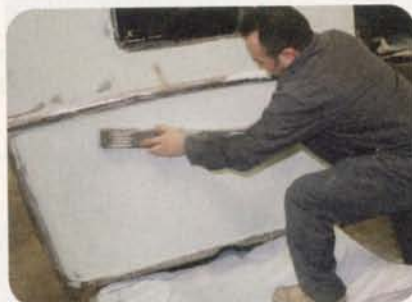
Important Tip: Soon John attacks the surface with a long foam sanding pad, working in an X-pattern to prevent flattening the panel. Some of these long foam sanding pads are supported with metal rods to keep them slightly curved. Remember all exterior surfaces are compound curves (in both directions) from side-to-side and top-to-bottom.

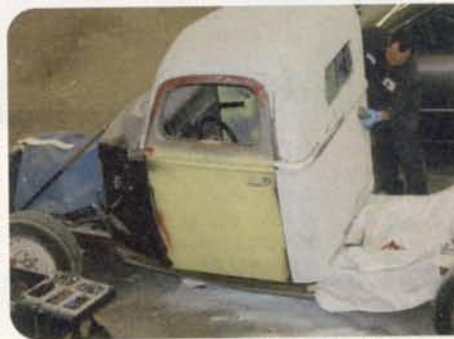
It's hard to say what percentage of the filler remains on the cab, but there's plenty of material both on the cab and on the floor. A good practice is to cover the engine and chassis. Plus, tape up any air holes that might collect small filler dust.

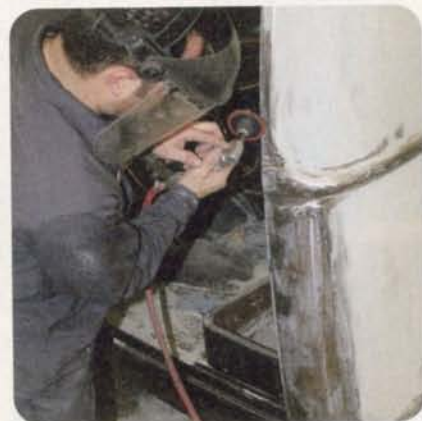
John cleans the restored rear corners of the cab and the door jambs with an air-powered rotary tool.

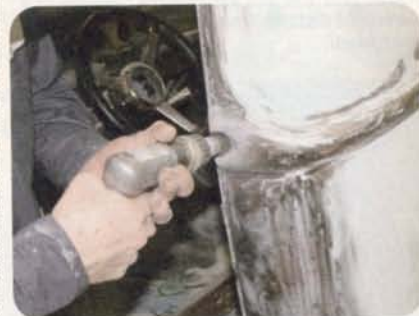
Important Tip: A wire brush on the rotary tool is good for thoroughly cleaning the tightly curved surface of the cab's body reveal. These surface changes serve to strengthen the exterior panels as well as improve the truck's styling.

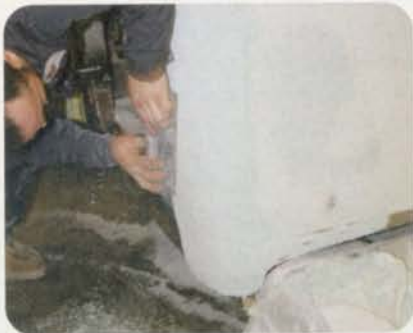
John works the cab's rear corner surface with a sanding block – again moving in an X-pattern for the most part. The bottom of the cab's corner has an inner and an outer wall. When the cab was restored, the corner was sealed with metal to prevent moisture from entering between the inner and outer surface.

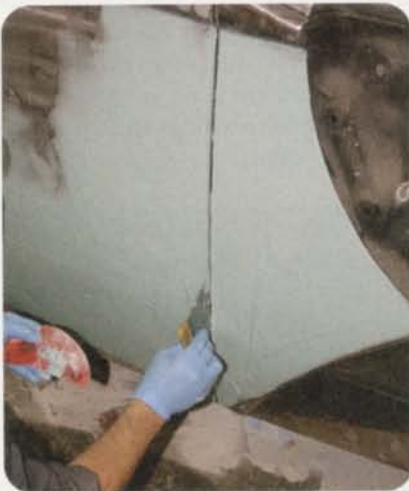
Important Tip: The door cut was sculpted shortly after the filler had “kicked” and was still somewhat soft. Waiting until the filler completely hardens takes a much greater effort to create and can often damage the edges.

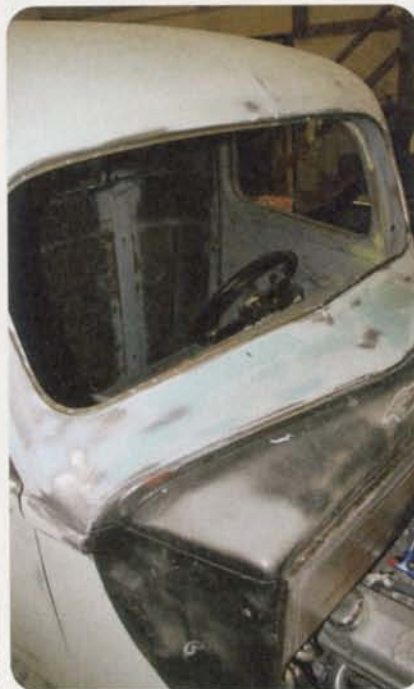
The top of the cowl was worked in several thin layers. This area is one of the few with a “fillet” or concave surface.

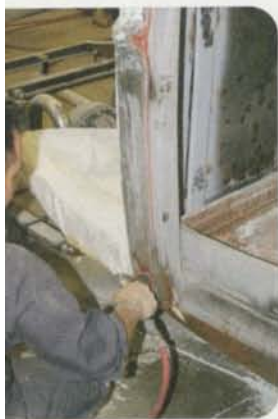
John moves to the passenger side of the cab, cleaning old filler and primer. We will extensively clean the inner floor and seat riser in the near future to prevent rust from attacking the interior metal surfaces.

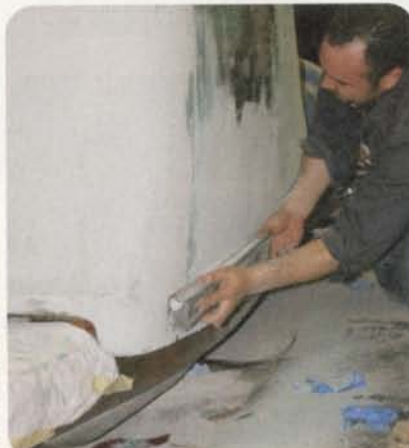
The long sanding board allows John to work from the cab's rear corner forward to the cowl. The continuous surface will likely be better than when the truck was brand new. Notice the amount of material on the floor.

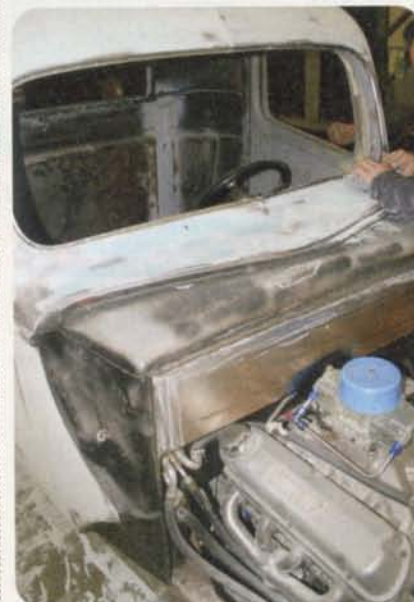
Important Tip: A concave surface is best worked with a curved surface tool, such as a rolled sanding pad. John uses a cardboard paper roll with sandpaper added. The sanding motion is still primarily in an X-pattern.

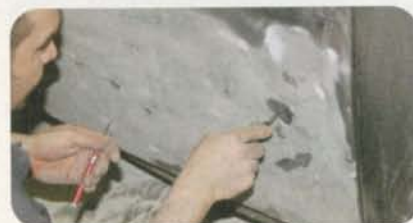
Minor high spots were identified and shrunk in the door skin. The 70 years of shifting loads, plus use and abuse have resulted in a variety of distorted metal on the doors and rear panel.

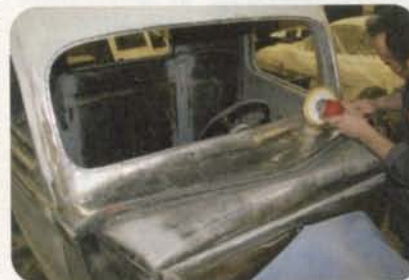
The top of the cowl was next on the list; every bit of surface rust was ground away. The weld area where the original cowl vent was located was ground smooth as a baby's behind.

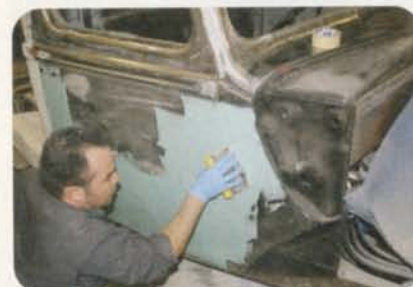
John works the passenger side door skin and the side of the cowl at the same time to create a continuous surface through the two panels.

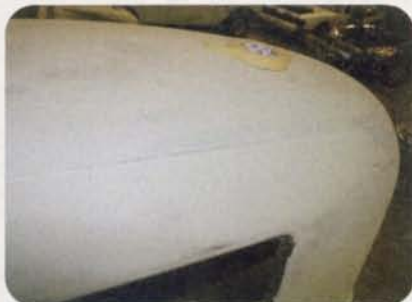
This image of the rear roof panel shows a surface change or seam between the top and the rear of the roof. We agreed that this detail was important to retain to prevent the transition of the roof from looking too soft.

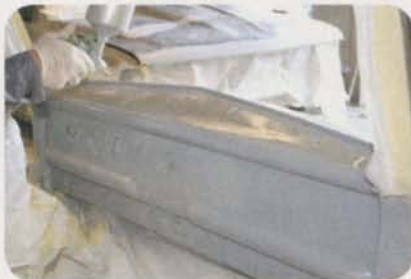
Alfred started priming the cab with the dash. A light tack coat was sprayed on initially, with more coats added as the preliminary coats began to kick. All of the paint and filler material is of a similar chemistry, a fact that aids in stability and longevity. Soon several counties in California will implement a water based paint system only.

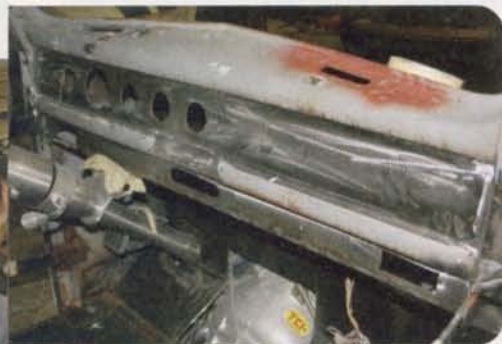
The dash will also be primed and painted body color – it needed to be prepared also. At least we've eliminated the unwanted holes in the dash and have fresh metal where the Classic Instruments gauges will be mounted flush to the dash panel.

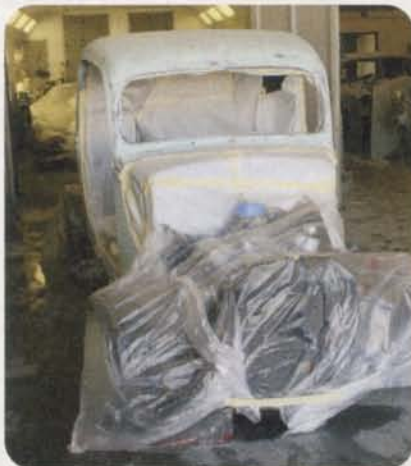
Brea Hills' crew taped off the engine and the rear of the chassis to prevent what little overspray was in the air from floating onto unwanted surfaces. The HVLP spray guns put much less material into the air than paint guns from a decade ago.

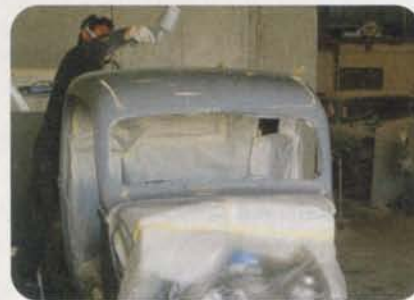
The crew cleaned with SHER-WILL-CLEAN® Solvent Cleaner – these products are also available: R7K156; AQUA-MATE™ Low VOC Surface Cleaner W4K157 or UltraClean® Surface Cleaner R7K158. Simply wipe dry with a clean, dry cloth. Alfred applied two or three medium coats of ULTRA-FILL for a very sandable surface. Complete instructions can be found on the Internet as well as on the can.

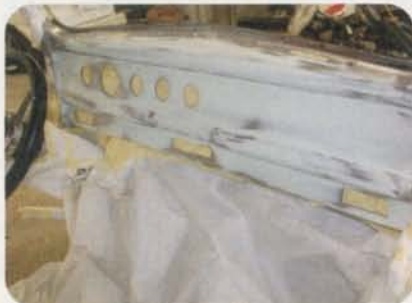
With filler on the dash panel and the added lower A/C panel, the dash is beginning to look much more integrated. We think the Classic Instruments analog gauges and the backlit Vintage Air A/C controls will look great, and very sanitary next to the unified dash surfaces.

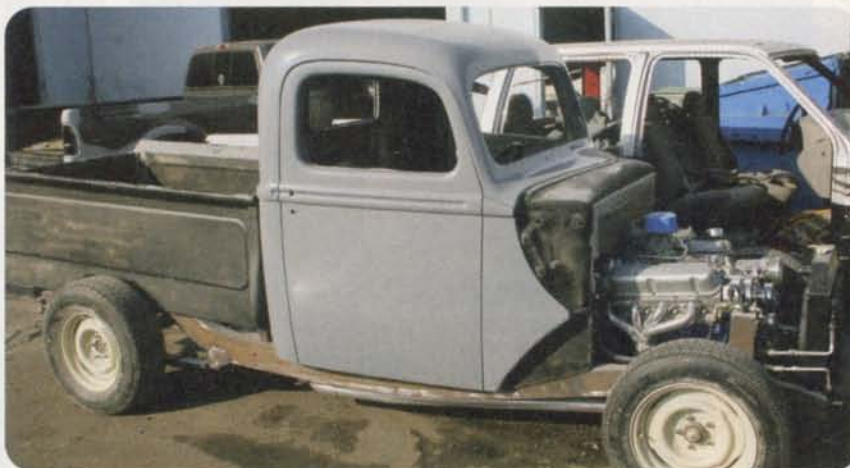
Here's how our '40 Ford pickup looked with the doors back on and the ULTRA-FILL primer dry. Our next goal is to assemble the front fenders, hood and grille. We didn't primer these items in the event that they may need some further adjustment in order to fit the cowl and hood. More good construction tips for 1940 Ford owners to come – stay tuned!
