THIS OLD TRUCK

Pro Paint Tips: Prepping and Reading Body Surfaces

We continue our coverage of the restoration of “This Old Truck” as it was treated to professional paint preparation at Brea Hills Auto Collision in Brea, California. Our last episode ended with the steel cab’s roof being surfaced and the rolled rain gutters shaped with a thin coat of plastic filler. This month we watched as John attacked the cab’s new rear panel, plus he also prepped the doors and cowl with a thin coat of plastic filler and much more sanding than we anticipated.

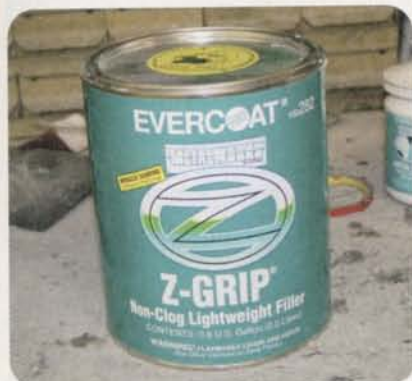
Brea Hills Auto Collision uses Evercoat Z-Grip with Hattonite, it's a quality plastic filler with excellent non-clogging sanding characteristics. Of course the filler is catalyzed with blue cream hardener before it's applied to the surface. The better quality fillers will shrink less as they cure to maintain a superior surface with excellent bonding characteristics.
